Home Inspection Report

1234 Any street, Hometown, USA

Report Number:
C050204-1

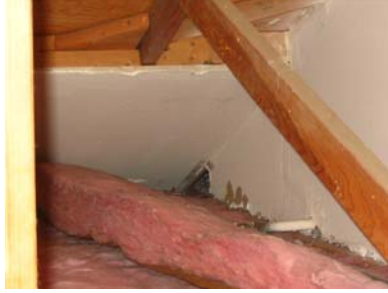
Garage

Safety Issue: Proper fire separation between the garage and house proper is recommended (holes in fire wall).

- **Repair, Safety Issue:** Proper fire separation between the garage and house proper is recommended (holes in fire wall).

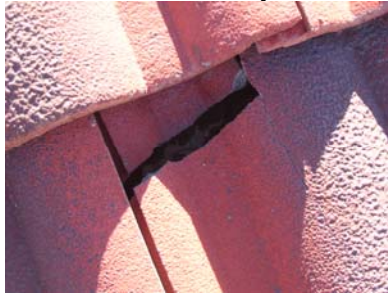
Sloped Roofing

Repair: Minor repairs to the roofing are needed. Damaged or missing roofing material should be repaired. All roof penetrations should be examined and sealed as necessary.

- **Repair:** Minor repairs to the roofing are needed. Damaged or missing roofing material should be repaired. All roof penetrations should be examined and sealed as necessary.

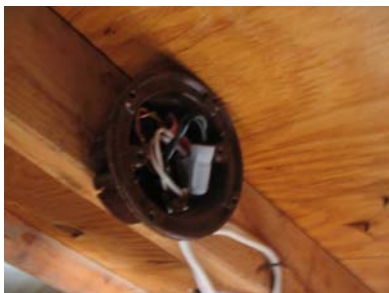
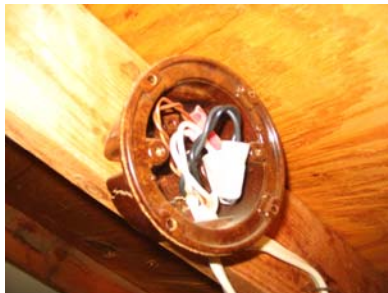
Distribution Wiring

Repair: All junction boxes in the garage attic space should be fitted with cover plates, in order to protect the wire connections.

- **Repair:** All junction boxes in the garage attic space should be fitted with cover plates, in order to protect the wire connections.

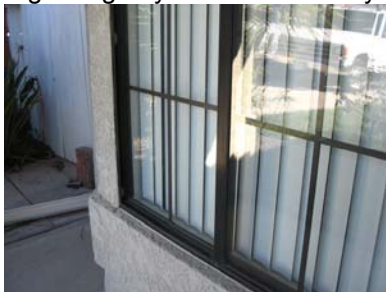
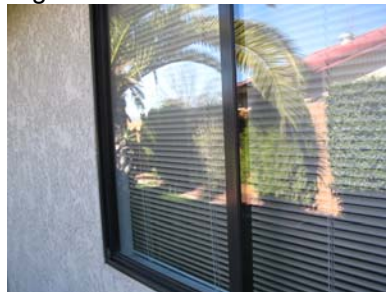
Windows

Monitor: It may be desirable to replace window screens where missing. The owner should be consulted regarding any screens that may be in storage.

- **Monitor:** It may be desirable to replace window screens where missing. The owner should be consulted regarding any screens that may be in storage.

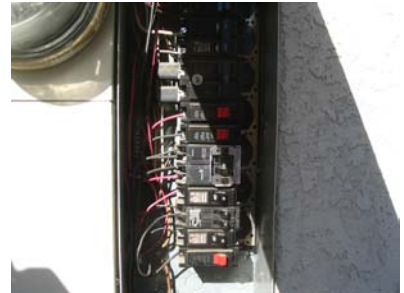
Electrical panel in good order

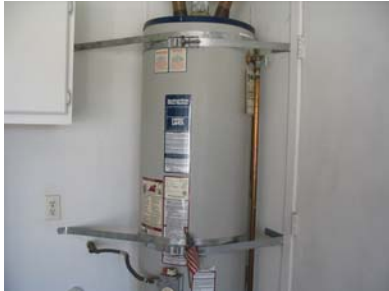
Water heater properly strapped

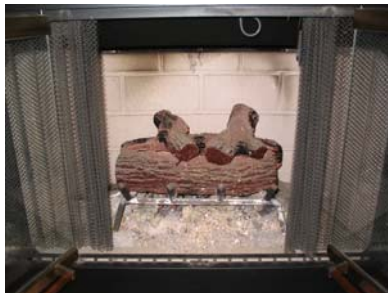
Fireplace in good order
